KOOTENAI DEVELOPMENT IMPOUNDMENT DAM

JULY 2011 ROUTINE OWNERS INSPECTION

Prepared for: The Remedium Group

Inspection Date: July 29th, 2011
Report Date: December 28th, 2011

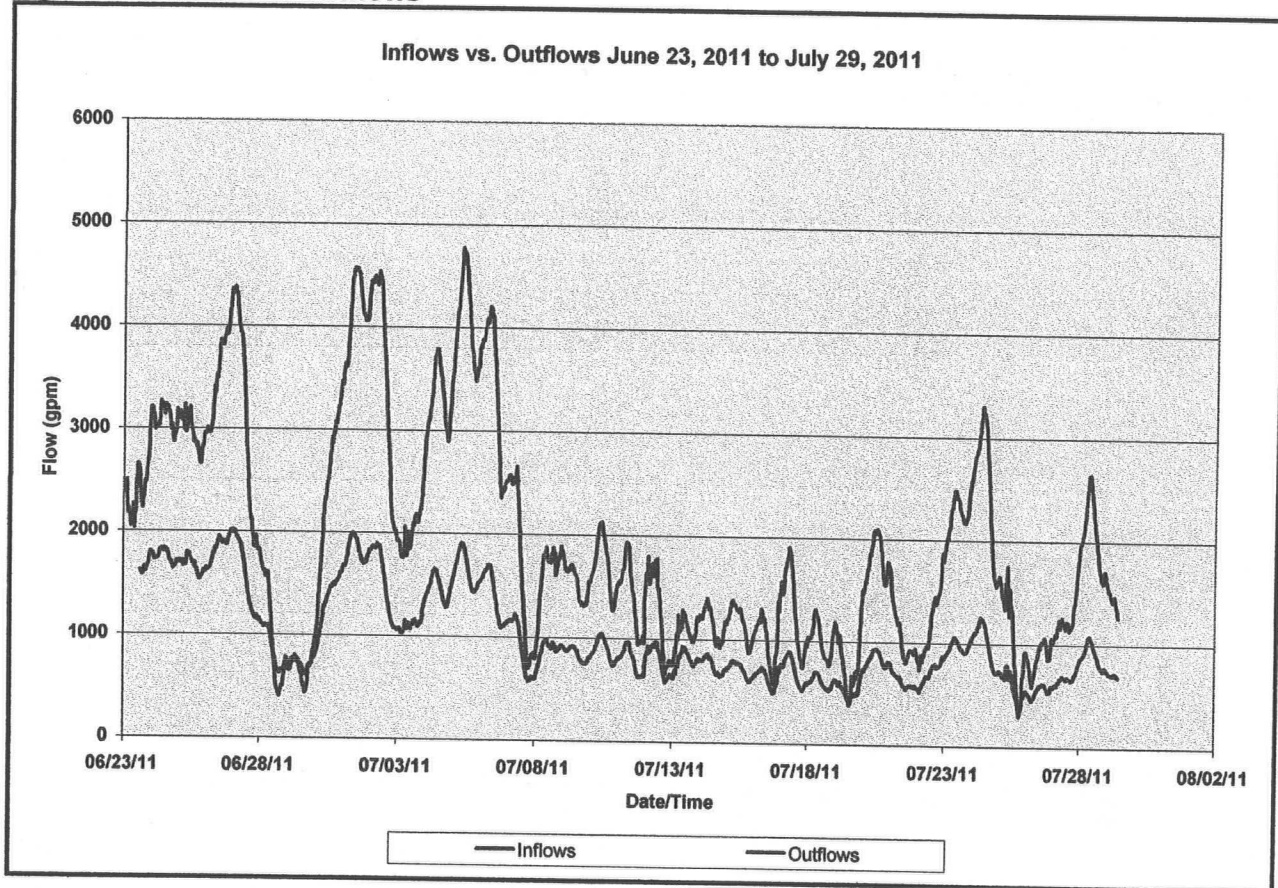
Figure 1: Inflows vs. Outflows

The graph above shows surface water inflows from Rainey Creek and Fleetwood Creek just as they flow into the reservoir and outflows from the toe drain system as measured at Lower Rainey Creek-01 (LRC-01) flume immediately below the toe drain collections system. Included in the inflows are the estimated values for Fleetwood creek and the spillway flows.

The most obvious characteristic of the graph is that outflows were consistently greater than inflows over the past month. Also of note in all the flow data retrieved from the transducers is the flow pattern, the rises and falls, at each transducer location. URC-02, reservoir, spillway, and LRC-01 transducers all change elevation along the same pattern.

This data is preliminary in nature and has not been corrected for barometric changes. However, there is an observable trend that indicates a possible direct connection to inflows above and into the reservoir and flows out of the drains.

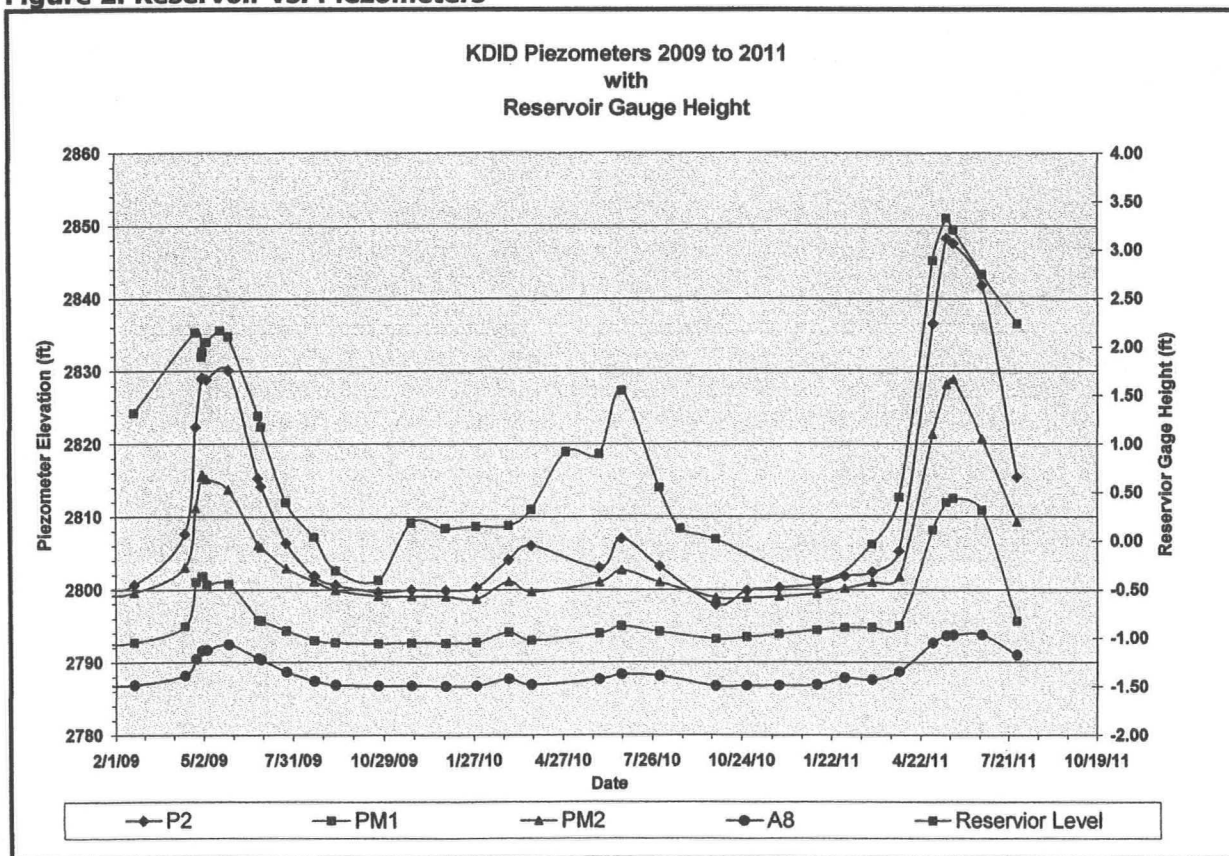
Figure 2: Reservoir vs. Piezometers

As shown above, during 2009 and 2010 there is a similar rise in reservoir and piezometer levels although there are some areas where either reservoir rise does not correlate to piezometer change, varies or lags behind. However, in 2011, there was observed to be an immediate and dramatic response between the reservoir and the piezometer levels. It is noted that the rise may be attributed to the more precise data collected by the transducers. It is also noted that the annual precipitation, and thus inflows and reservoir levels, were higher than previously observed.

In 2009 reservoir levels rose throughout the winter and reached a staff gauge reading of 1.32 feet in early May before there was a significant response in the embankment piezometers. In 2010, reservoir levels rose to 1.55 feet in late February before there was an observed rise in piezometer levels. In 2011 we observe the reservoir start to rise with the piezometers responding almost instantly to the rising reservoir levels. We also observed that piezometer rise continued until the peak inflow conditions and then immediately started to fall. Therefore, at least for 2011, we note that as soon as reservoir levels rose above the base winter level and started to be able to be read on the staff gauge, at a reading of 0.00 feet, there was an immediate and significant reaction in the piezometers to rising reservoir levels with no observable lag time.

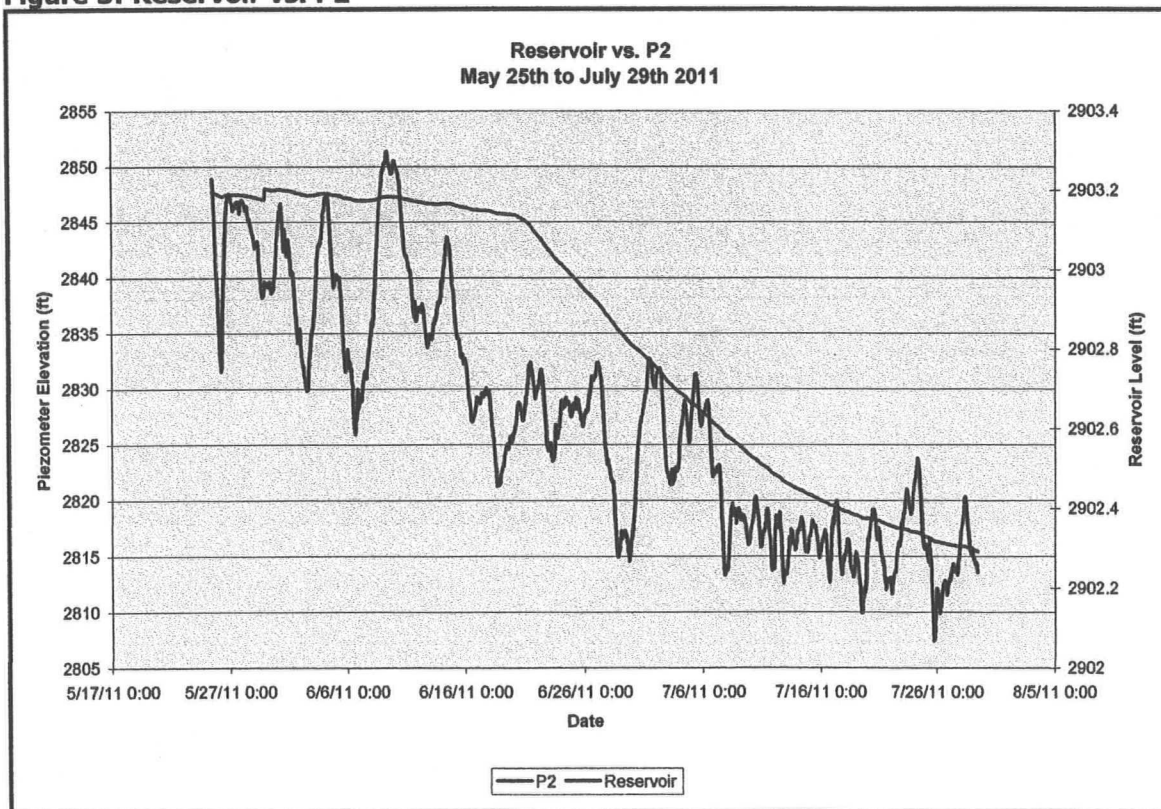
Figure 3: Reservoir vs. P2

Figure 3 below shows a comparison of reservoir levels and piezometer P2. As can be seen, water levels in piezometer P2 stay relatively constant until June 21st and then start to decline rapidly. Chapman Construction noted that the only observable anomalies during that time frame was that water that had previously flowed over the north end of the reservoir access road to a small side pond on the west side of the access road had ceased to flow and the side pond had rapidly drained.

The potential to have an open drain source in the side pond area is worth investigating as reservoir levels have been shown to affect foundation pressures. It may be that when the side pond is full it may provide a source of pressure to the foundation drains.

Also shown in the figure above, is a small upward spike in the piezometer reading on May 29th. There was no seismic event at that time and the continual fluctuations of the reservoir levels give no indication why there was a sudden rise when all trends are falling. The spike in water level is discussed in the piezometers section below.

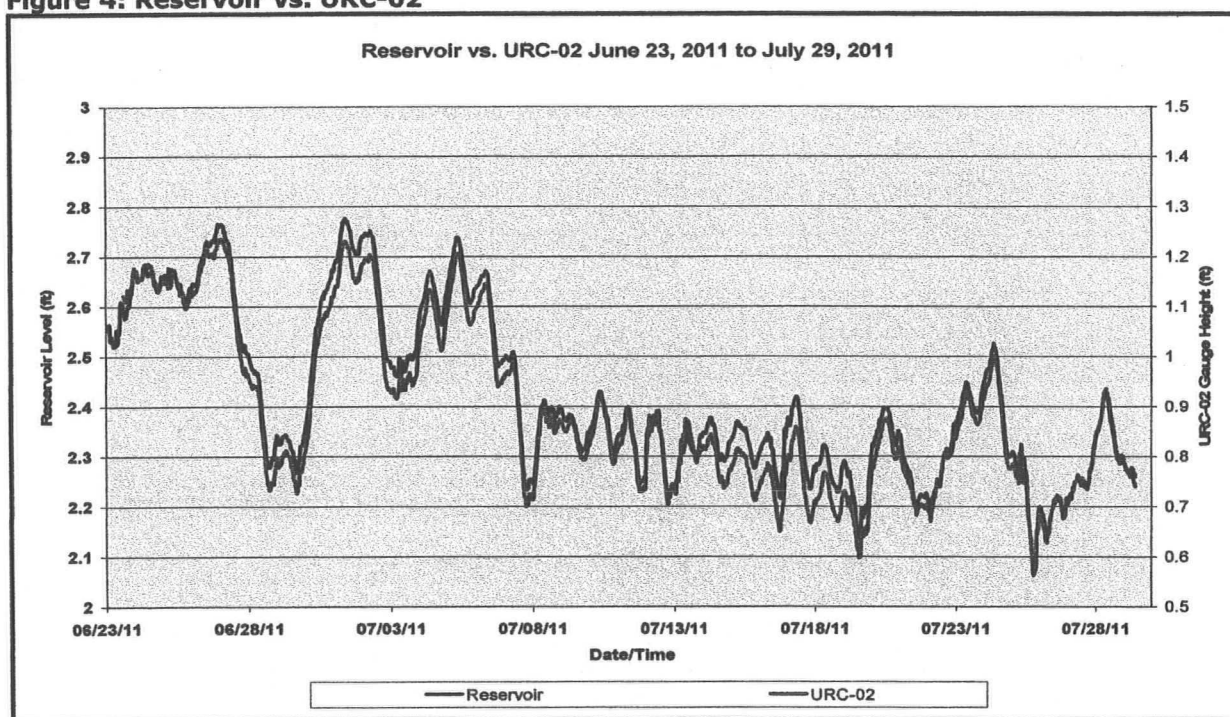
Figure 4: Reservoir vs. URC-02

The variation in reservoir levels recorded by the Solinst® transducer was also surprising and showed much more fluctuation than was expected. What was even more dramatic was to make a comparison between the reservoir and the Upper Rainy Creek-02 (URC-02) transducer data which is shown in Figure 4 below.

As shown, the reservoir reads slightly higher than URC-02 which is expected because of the Fleetwood Creek inflows. It was assumed that the reservoir would attenuate the inflows and reservoir level changes would be dampened but transducer data shows that the inflow-reservoir level lag times of less than half an hour, which was the recording interval. This data shows that the water flows into the impoundment and to the spillway quicker than anticipated. This data indicates that there is likely a loss of storage capacity in the reservoir. BHI has noted that the cattail growth on the margins of the reservoir have increased and it is likely that the reservoir is somehow experiencing eutrophication possibly from the waterfowl, and the increase in cattails is creating a loss in reservoir, and thus flood routing, capacity. It is also likely that the reservoir has lost capacity from siltation. Inflows, reservoir levels and spillways flows will be tracked in 2012. The reservoir depth will be checked during the winter of 2011 and 2012 when ice allows for easier access.

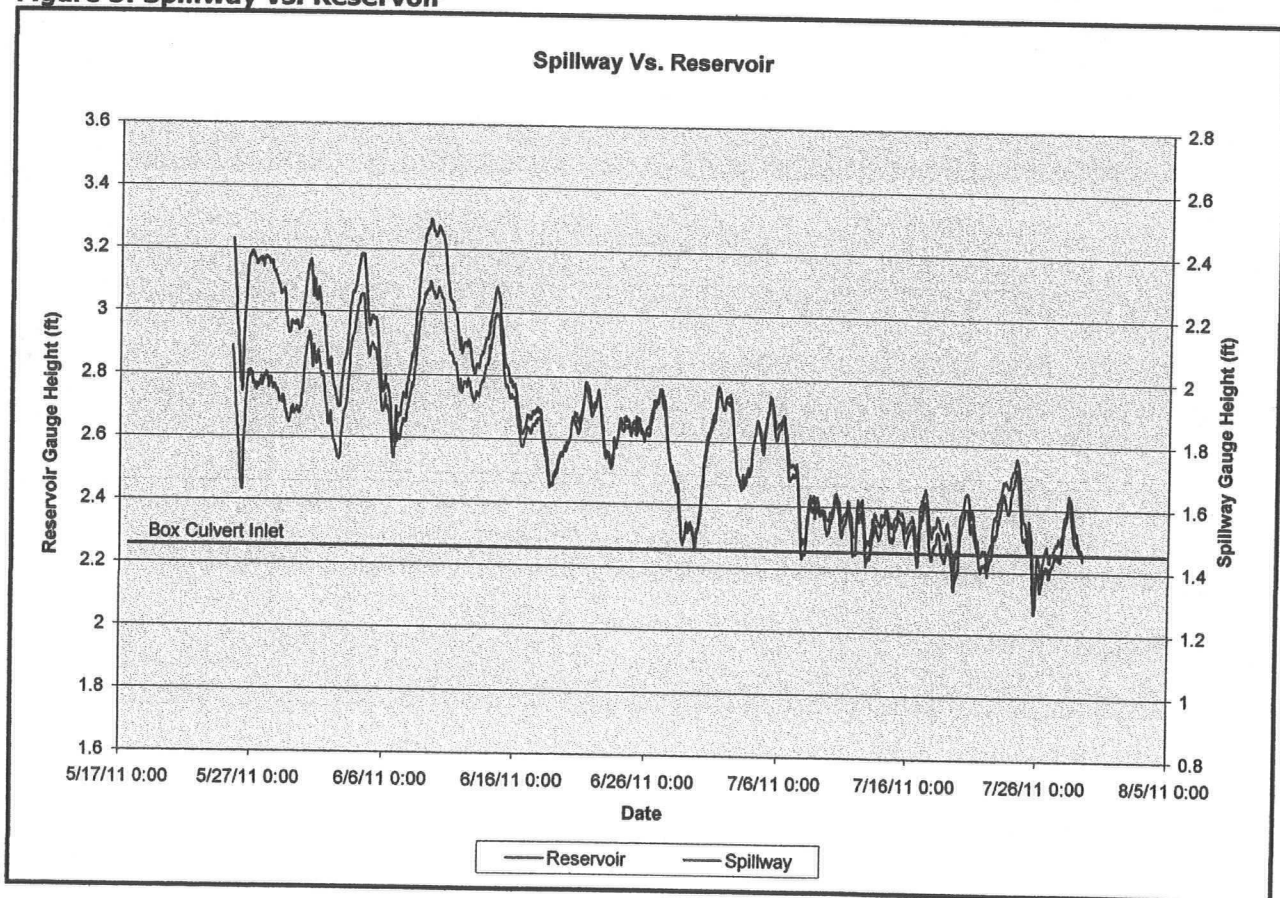
Figure 5: Spillway vs. Reservoir

The red "Box Culvert Inlet" line in the graph above shows the level at which water starts or stops flowing into the box culvert spillway. As shown above, the spillway stopped intermittently since the 8th of July. Based on the elevation data it is possible

that the spillway may continue to run sporadically for a few more weeks until fluctuations in reservoir levels permanently remain below the box culvert entrance channel inlet.

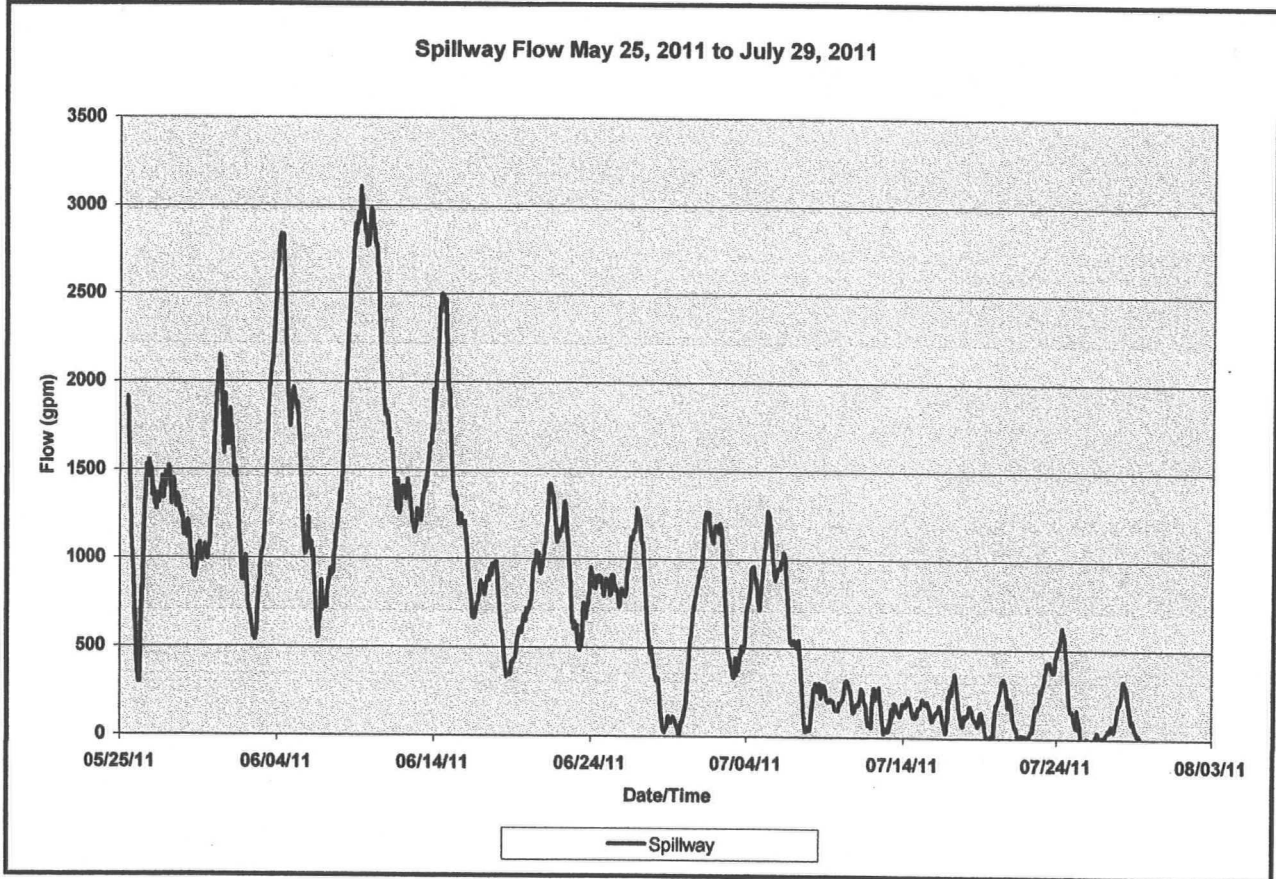
Figure 6: Spillway Flow

The staff gauge readings in the spillway were used to develop a flow rate versus staff gauge rating table using one on-site flow measurement, the measured channel slope, a measured cross section and the program FlowMaster®. The measured flow was used in the FlowMaster® program to solve for the Manning's Roughness coefficient which was adjusted for roughness changes at different elevations in the channel based on best engineering judgment. A final rating table was developed and used to graph the total spillway flows from May 25th, 2011 until the date of the inspection. The graph of the data is shown in Figure 6 below. Based on the data from the transducer levels and the rating table, approximately ## AF of water flowed through the spillway in 2011.

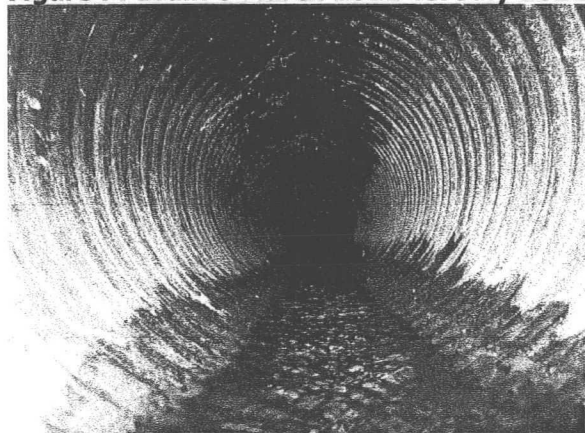
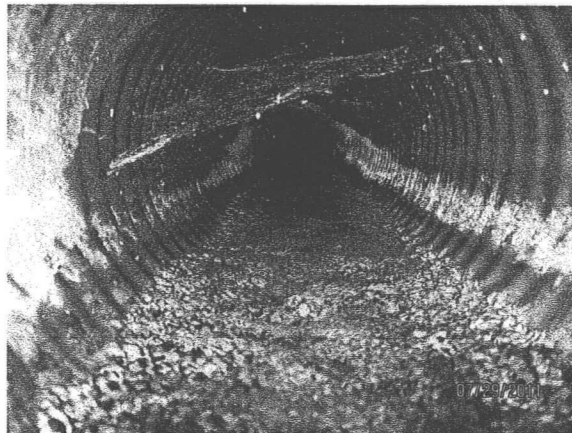
Figure 7: Drain 3 March 2011 vs. July 2011

During this inspection a pile of newly deposited gravel was noted near the outlet of drain 3 that was not obvious in previous months. Also noted was an increase in gravel material deposits inside drain 3. In addition to the gravel transport noticed below drains 10 and 11 last month, it is readily apparent that gravel drain material and possibly embankment material was transported through the drains this spring by the higher flows. Figure 7 below shows the difference in gravel deposits from March to July of this year.

Before this spring and under normal operating conditions, material transport through the drains was not obvious or noted during site inspections. This transport of material will be monitored closely to determine if transport still continues under normal conditions.

1. **Re-video Drains 3, 10 and 11:** These drains were noted as passing embankment material this spring. A video may provide insight to the amount of material that passed through the drain system and their current condition. Video may also indicate the presence of one or more voids in the embankment.

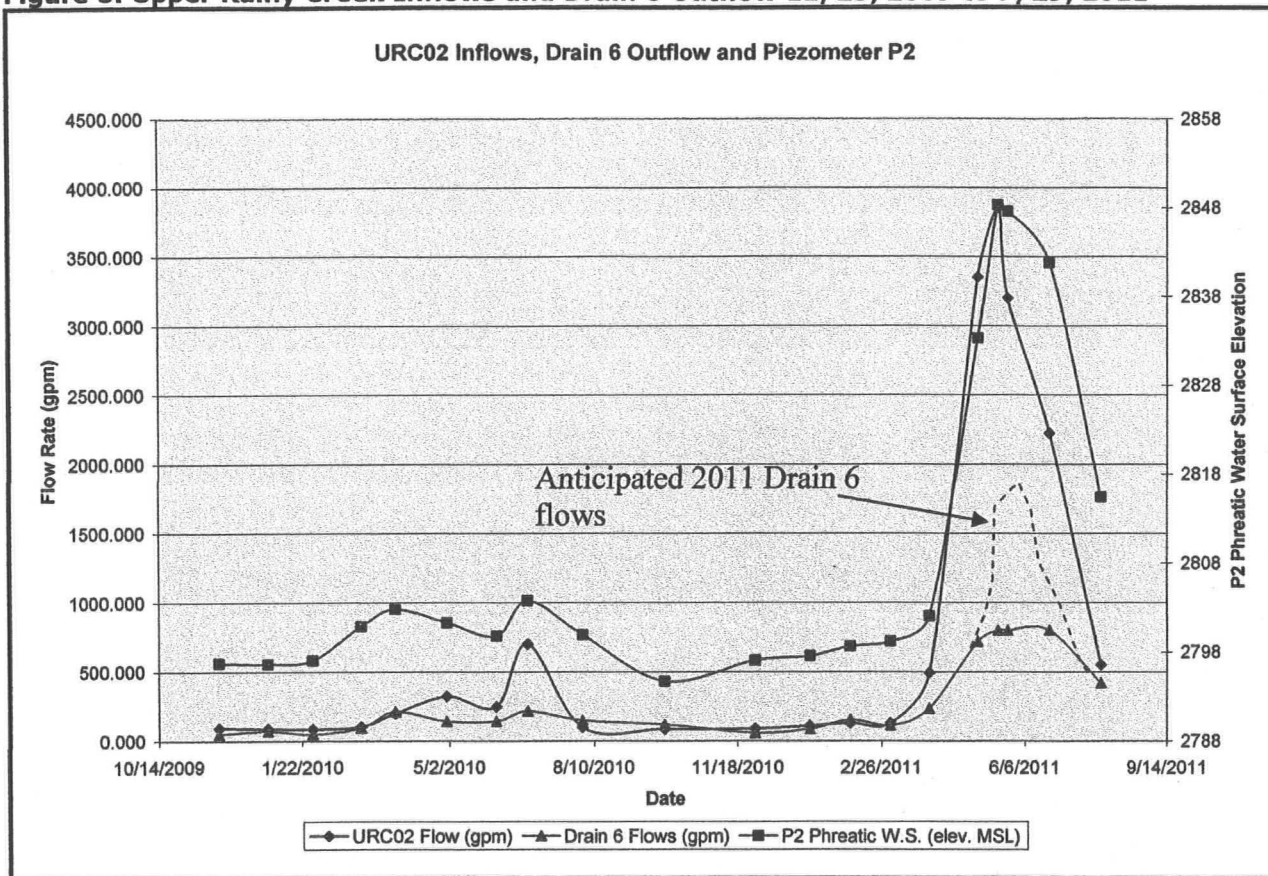
Figure 8: Upper Rainy Creek Inflows and Drain 6 Outflow 11/25/2009 to 7/29/2011

Drain 6, the main toe drain, has decreased flows in the past month and was recorded at 421 gpm on the date of this inspection. Drain 6 had steady flows near 800 gpm from May 18, 2011 to June 23, 2011. The flows for 2011 were approximately 300 gpm less than the highest recorded flows in May of 2008. As discussed in earlier reports, data this spring suggests that drain 6 may have lost some capacity since 2008, which may be putting higher stresses on other drains in the system which in turn may be the cause for the gravel and sediment transport. Figure 8 below compares drain 6, Upper Rainy Creek inflows and piezometer P2 levels from late November of 2009 through the end of July 2011.

The graph above shows the flat, steady flow in drain 6 after the middle of May that is either declining capacity or a flow capacity limit in drain 6. It is noted that BHI observed flows near 1,100 gpm in 2008 so it would be expected that drain 6, if it followed the rise in inflow and reservoir levels normally, should have peaked near 2,000 gpm, as shown in the projected line in Figure 8 above.

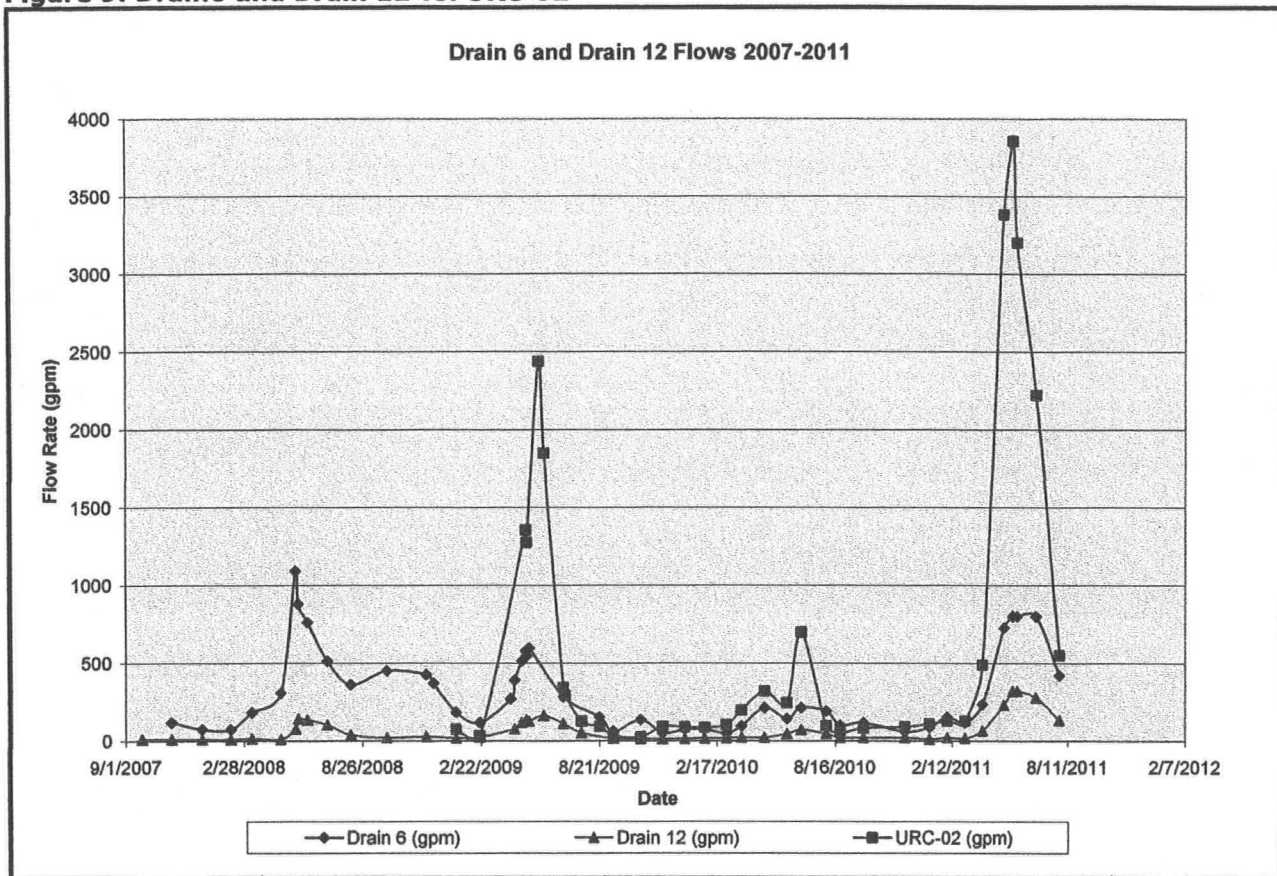
Figure 9: Drain6 and Drain 12 vs. URC-02

Drain 12 has decreasing flows this month and was recorded at 112 gpm down from 255 gpm, a decrease of 143 gpm or 56%, since the June inspection. The decrease has allowed substantial drying of the saturated area above the drain as well as a reduction in seepage flows around the whole drain 12 area as previously reported. Nearly all flows are going through the W12 weir at this time rather than over topping as was reported in June. It was noted during this inspection that sustained high flows have caused the weir to shift and there is some leakage around the sides of the weir but are estimated at less than 5% of the total flow. Figure 9 below shows an updated comparison of URC-02 inflows and drains 6 and drain 12 outflows.

As can be seen, inflows and outflows, as reflected in drain 6 and drain 12, all correlate closely.

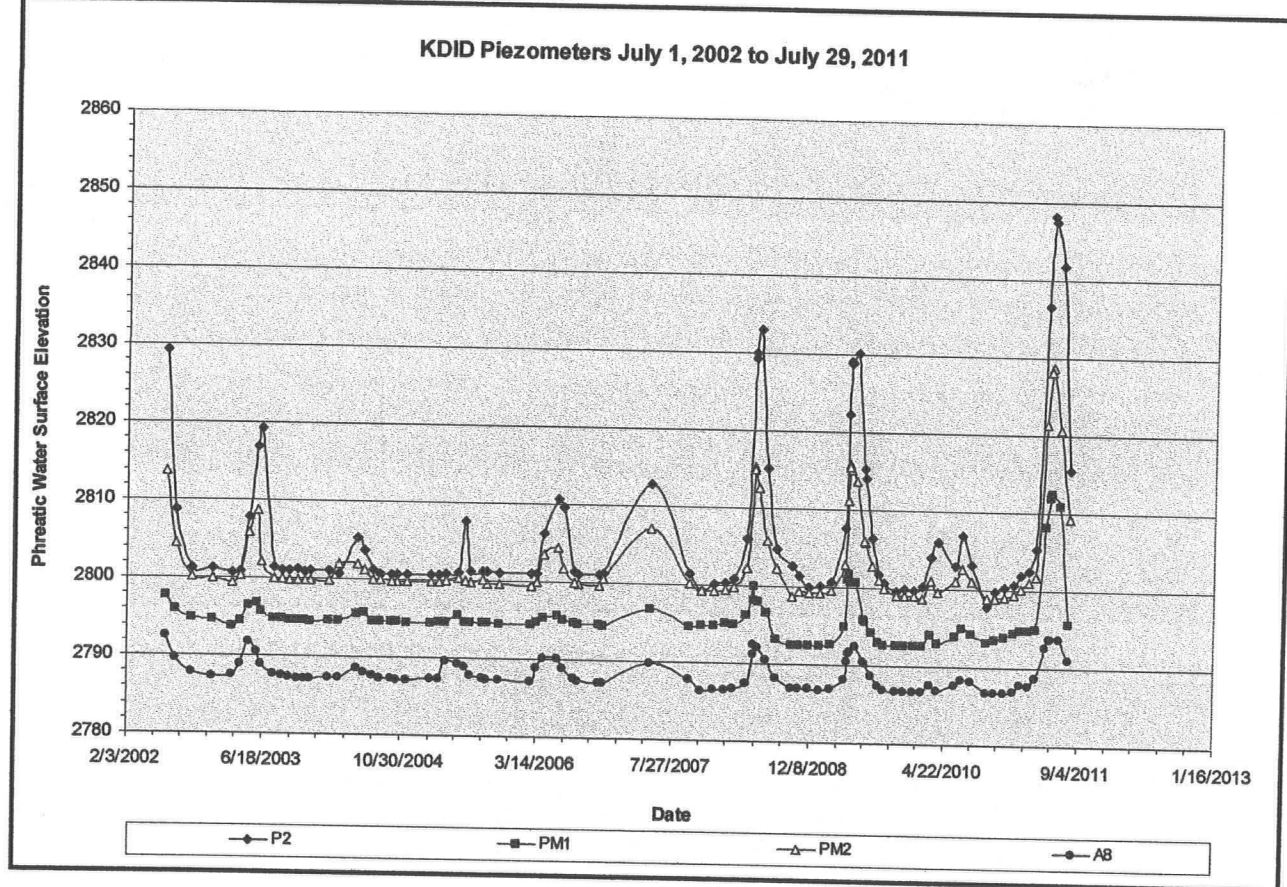
Figure 11: Updated Piezometer Plots

The updated piezometer plots from the 2002 data provided to BHI to the date of this inspection is shown in Figure 11 below and shows the seasonal peak levels that have occurred since 2002. It is to be noted that the peak in piezometer levels is consistent each year but the date of the peak and the duration of the peak vary from year to year. The peak for this year occurred on May 18, 2011 and there was not a second peak; the levels have been declining since.

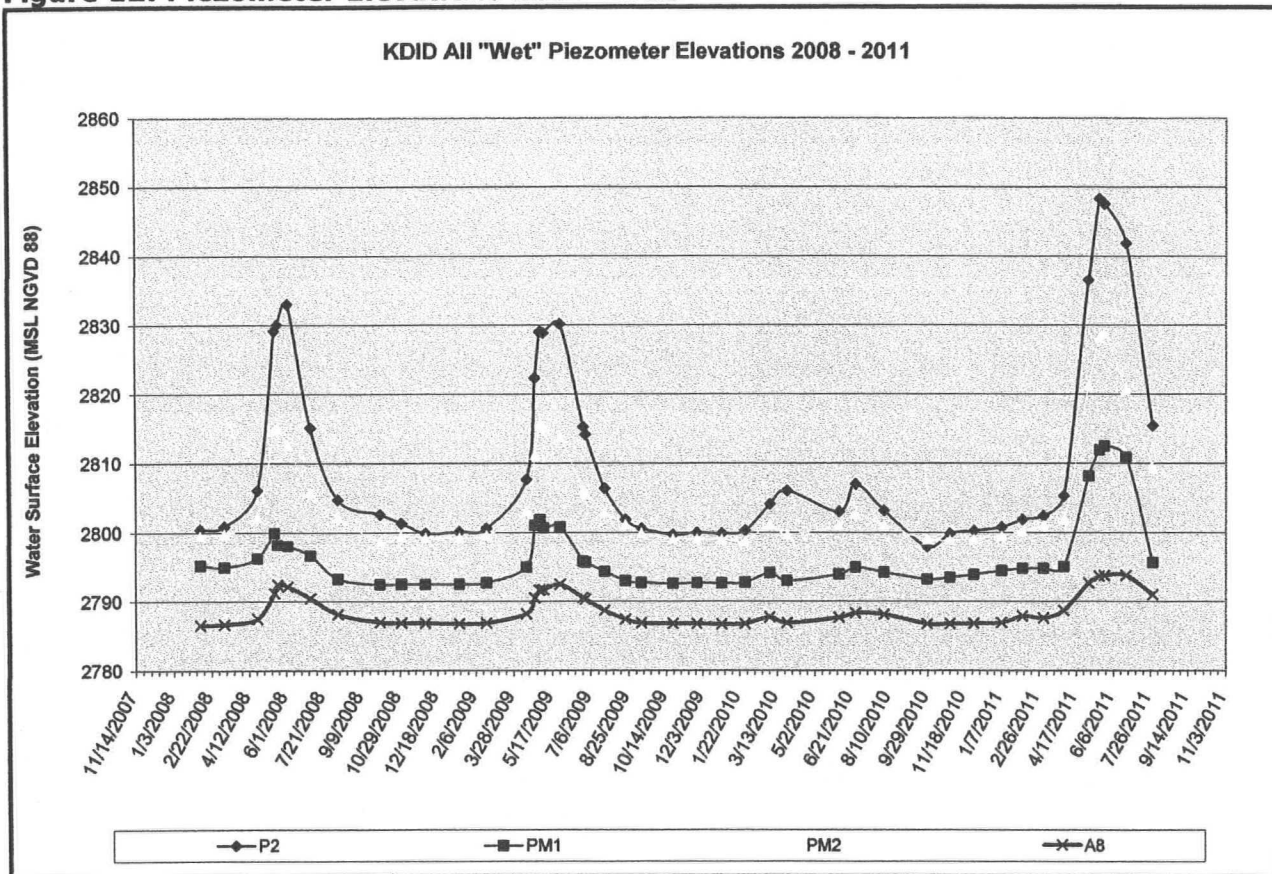
Figure 12: Piezometer Elevations 2008-2011

A graph of the same piezometers from Figure 11 above, graphed over a shorter period of time, is shown in Figure 12 below. The graph below represents just the piezometer data collected since BHI began onsite inspections.

The graph above also shows that the piezometer water levels observed this year are the highest recorded to date. At this time all seasonally wet piezometers are still higher than normal for this time of year but are falling normally. It is the opinion of BHI that the higher piezometer levels, and thus higher pore pressure in the drain system, may be directly correlated to the increase in gravel and sediment transport from the drains.

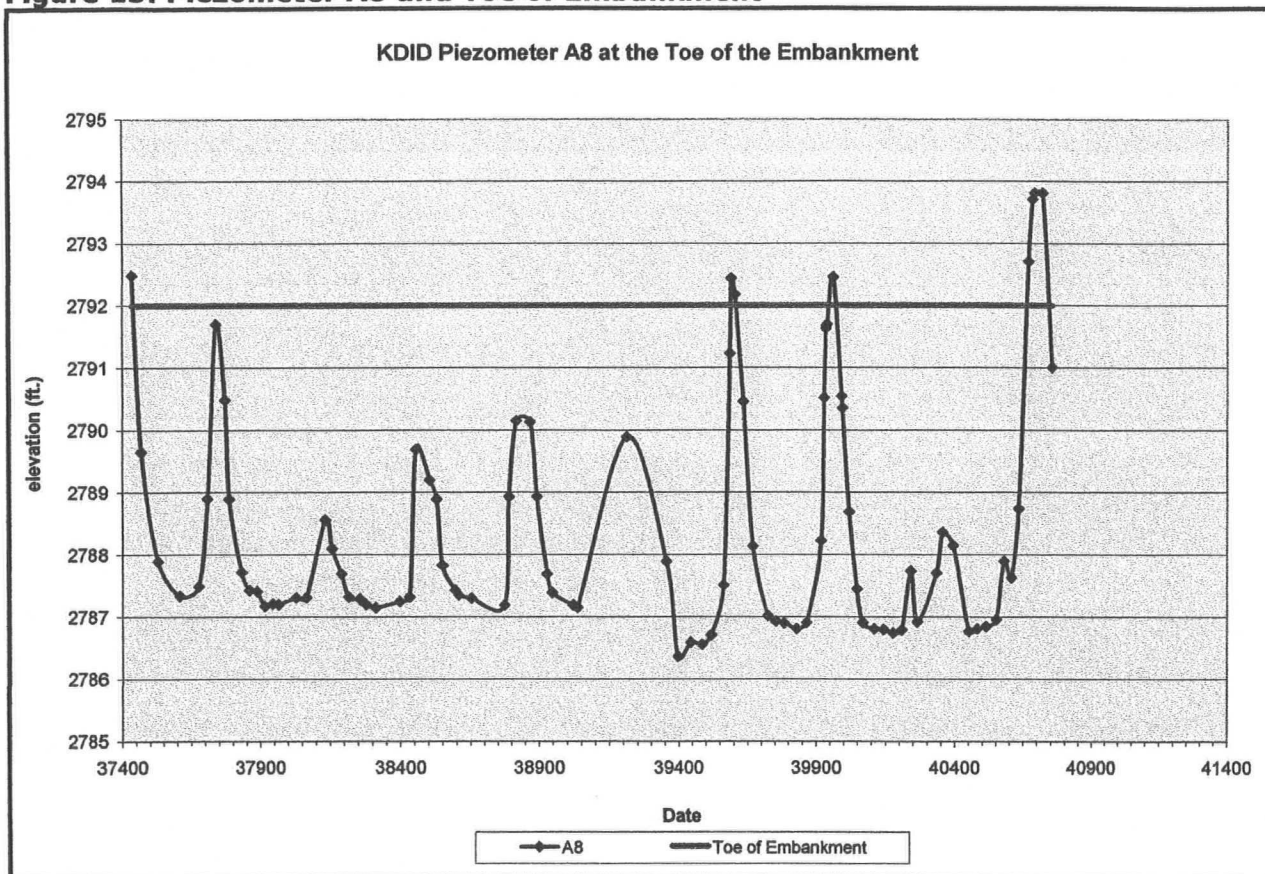
Figure 13: Piezometer A8 and Toe of Embankment

The water level in piezometer A8 has finally dropped below ground level and the ground surface has started to dry out in the saturated area at the toe of the dam and there is a decrease in overall seepage around the drains. Water was still noted seeping from the creek banks into lower Rainy Creek above the LRC-01 flume. Figure 13 below shows a graphic relationship between the water level in piezometer A8 and the elevation of the ground surface at the toe of the embankment. As can be seen, the increase in pore pressure at the toe is recorded by piezometer A8, and typically manifests as saturated ground at the toe and along the creek bank. This data shows that there is significant amounts of water that continue to flow through the gravels at the toe of the embankment and that there is a limit to the flow capacity. When the flow limit is reached, the water rises to the surface. This data indicates that higher flows will cause an increase in saturated ground at the toe of the dam.

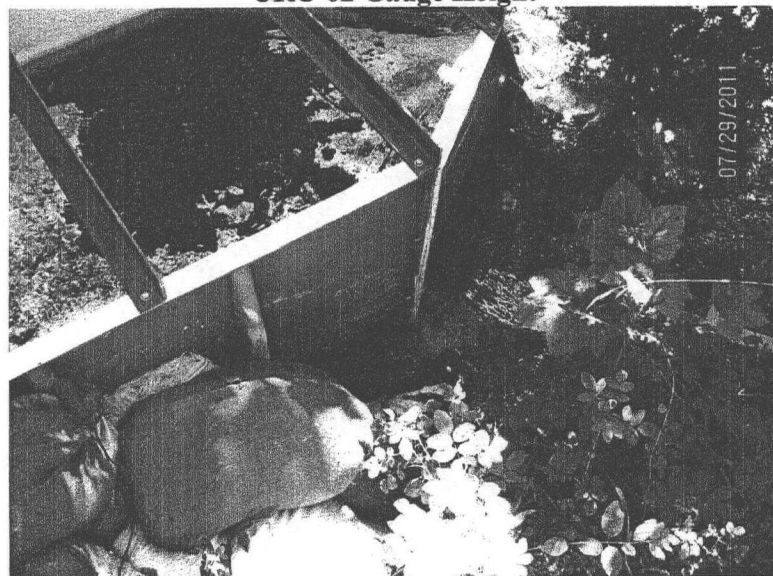
- a. The URC-02 Flume was read and the gauge height was recorded at 0.76 feet. Leakage is occurring on the sides from high water and the best sandbagging efforts have resulted in an estimated leakage of less than 5%. Bentonite is needed to complete the seal around the flume.

URC-02 Leakage

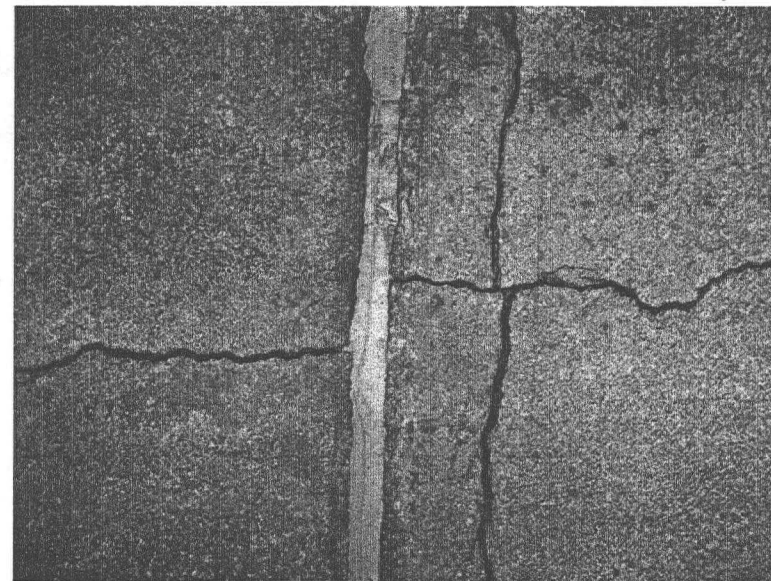
Cracks in Box Culvert Ceiling

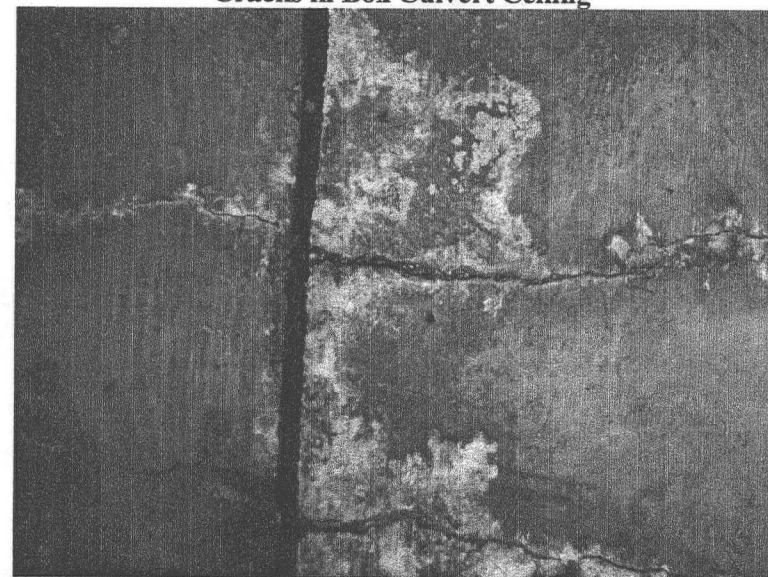
More Cracks in Box Culvert Ceiling

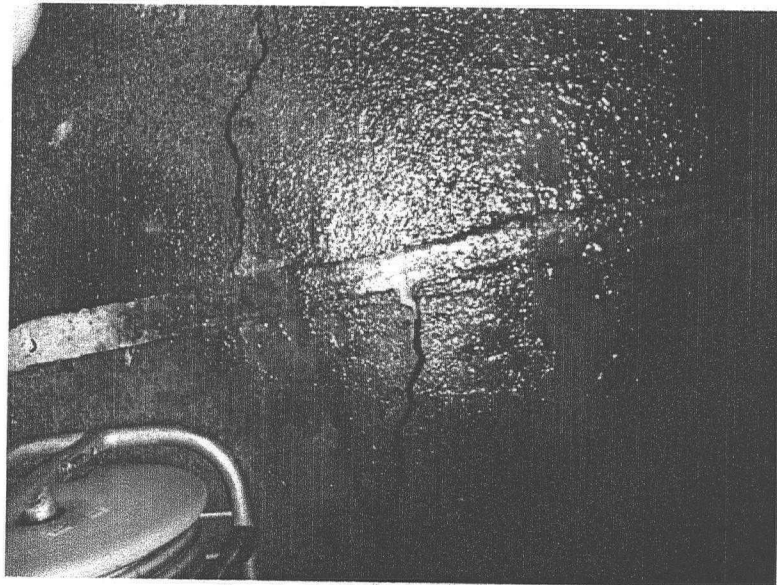
Cracks in Box Culvert Floor

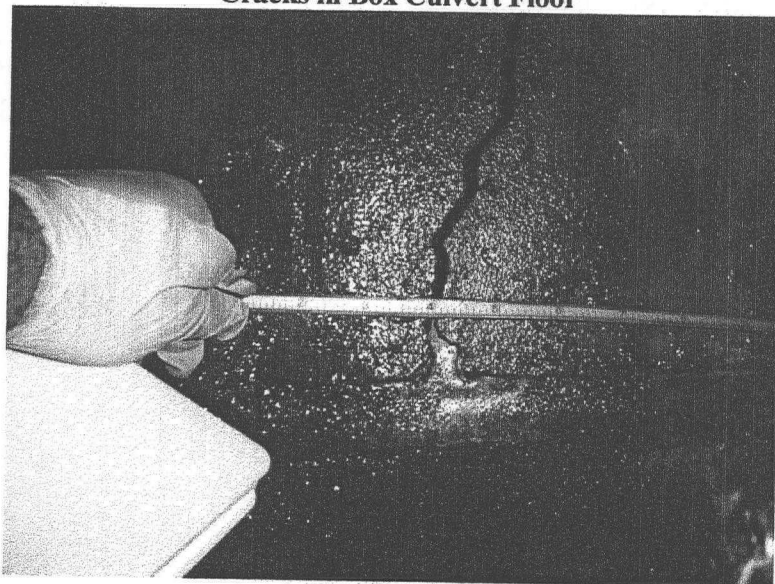
Crack Width

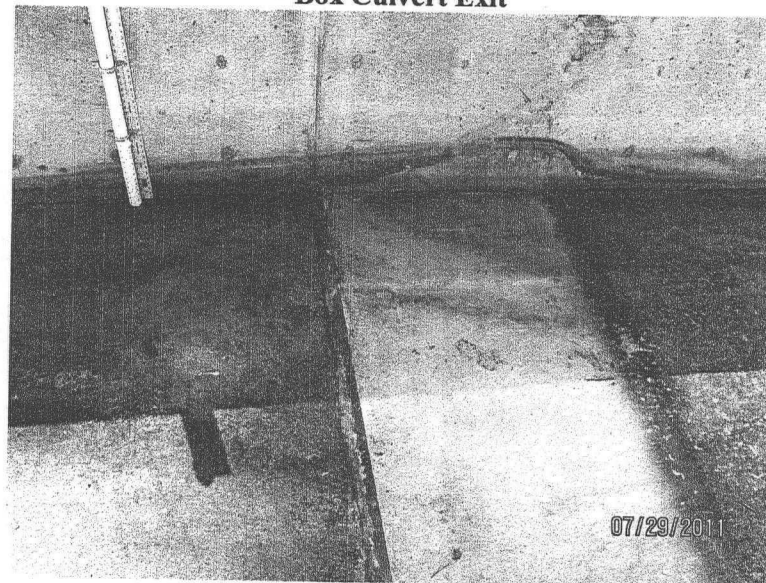
The principal spillway was not running on the date of this inspection but water was up to the lip of the box culvert in the entrance channel. Jeremy Peterson of Chapman Construction stated that the spillway was still running yesterday (July 28th). Based on this information and the data on the first day the spillway ran, the spillway ran for 108 days this spring. The period was longer than any other runoff witnessed by BHI. As stated above, black deposits noted in the spillway channel this spring indicate sediment is being transported through the principal spillway; it has not been observed in the spillway before this date. Chapman Construction has brushed areas of deposits away to make joint repairs in the chute this summer and stated that the deposits, once dried, are hard to clean which tends to indicate an organic sediment.

Sediment Deposits in Spillway at Flume Location

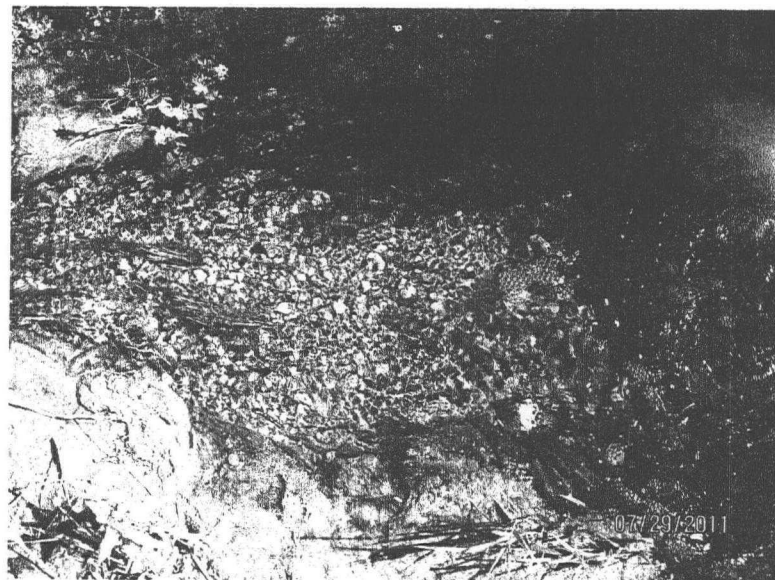
Gravel Pile near Drain 3 Outlet

- e. Determine lag time between inflows and drain outflows
4. **Monitor sediment transport:** Establish benchmarks near the drains that exhibit sediment transport and monitor stream channel cross section elevations. Currently drains 3, 9, 10, 11, and 12 are recommended for elevation monitoring

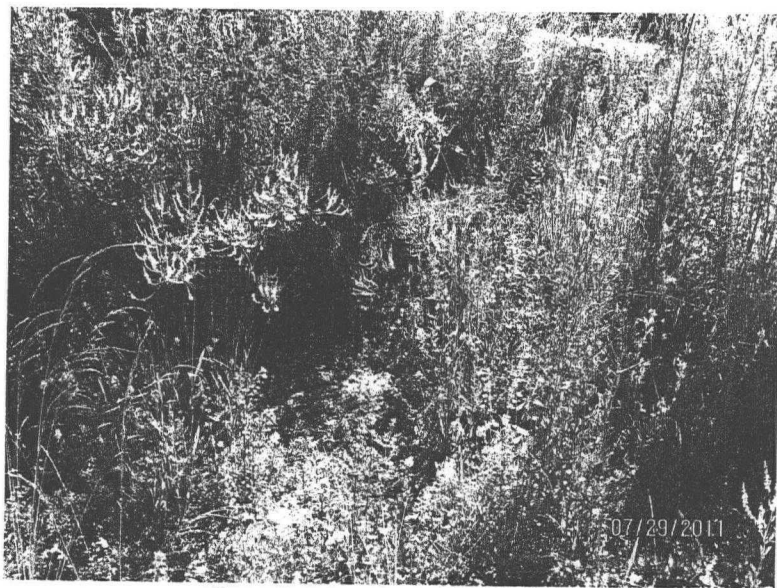
Seepage Area below Drain 7
